Project full name: **Integrated Project to evaluate the Impacts of Global Change on European Freshwater Ecosystems**

Deliverable No. 125
REPORT ON THE RECOVERY OF THE BECVA RIVER
(CZECH REPUBLIC)

REPORT ON THE RECOVERY OF THE BEČVA RIVER (CZECH REPUBLIC)

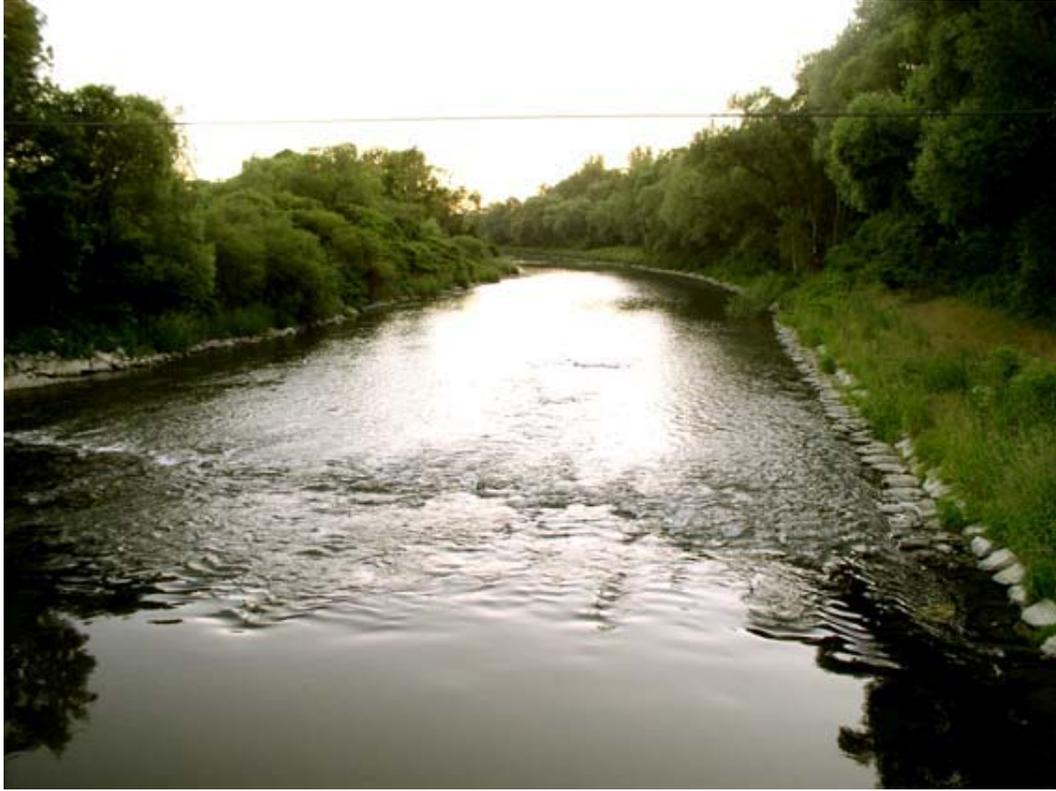
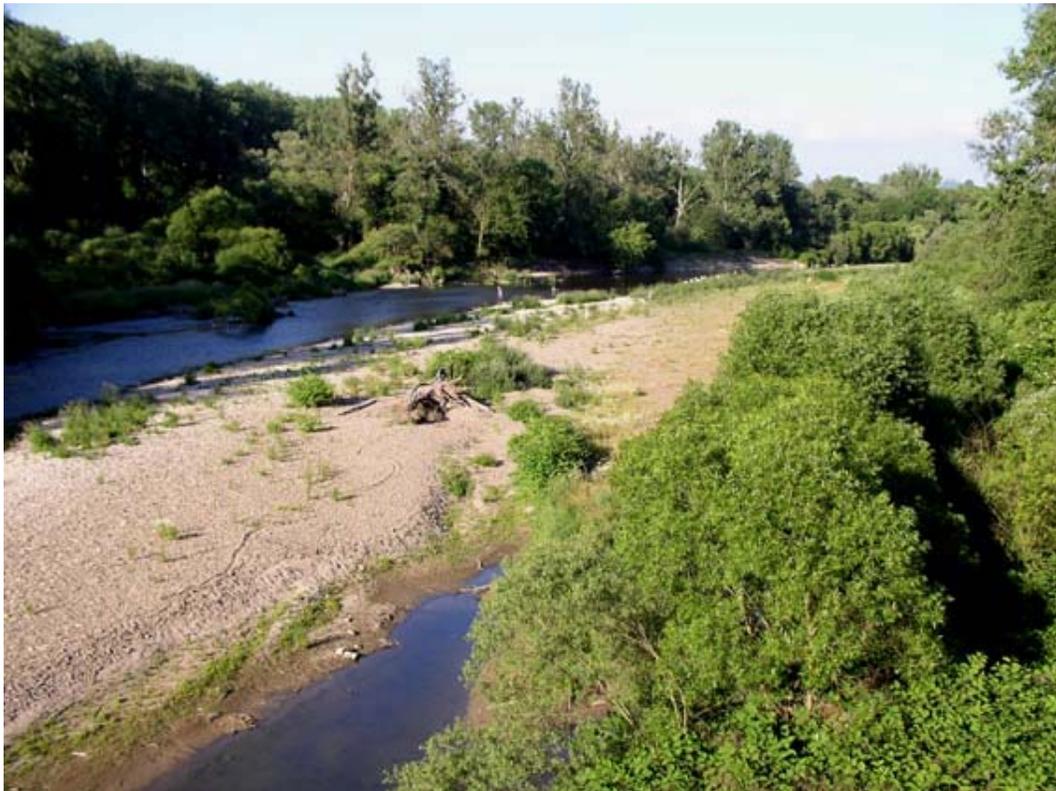
Fig.1. Comparison of regulated and restored sections near Černotín (photo by V. Syrovátka).

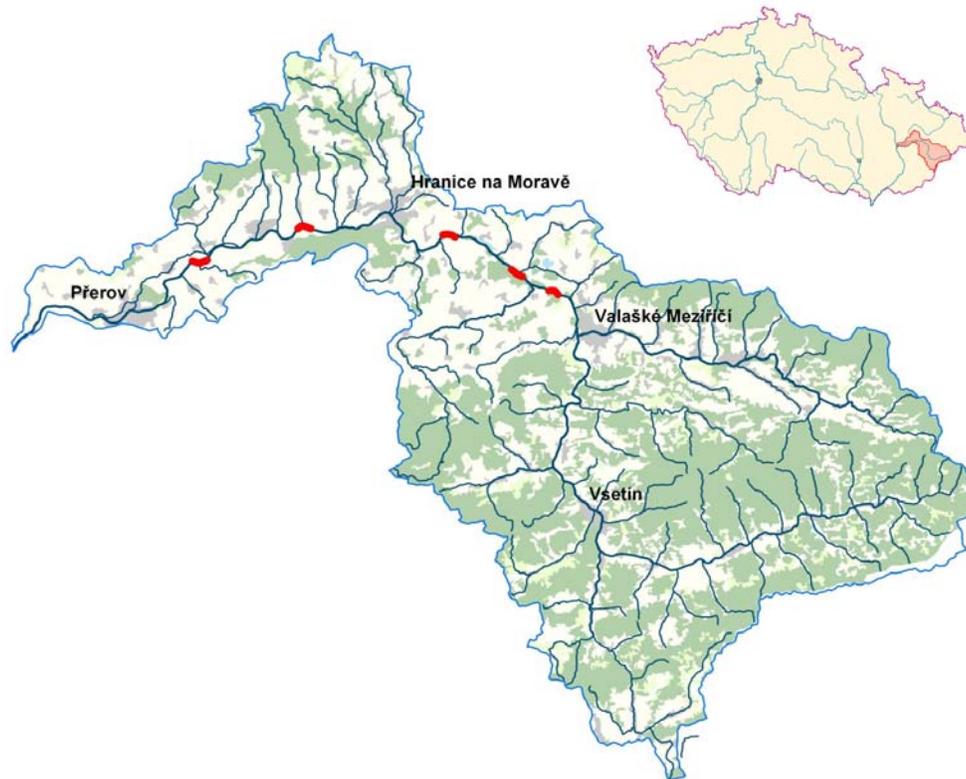
Fig. 3. Location of Bečva River stretches kept for restoration (red bands)

When repairs of flood damages started the Ministry of Environment was very interested in the conservation of new restored ecosystems on the Bečva River. There was a study drawn up where the Bečva River was divided into segments according to recommended treatments (Šindlar, 1997). Five stretches were placed into the category of a priority protection. Based on an agreement between the Water Basin Authority as the Bečva River manager and the Agency for Nature Conservation and Landscape Protection of the Czech Republic it was decided to keep five stretches without any follow-up regulation (Fig. 3). This initial restoration step protected those hydromorphological structures that had been documented from period before the regulation of the river. Hydromorphological studies (Šindlar, 2000) confirmed that these naturally restored sites represent hydromorphological conditions rare in the Czech Republic where the majority of river courses of that type are completely regulated (reinforced, resectioned, straightened, impounded). The planning process was started with activities combining restoration and flood protection. The protection based on a status of National Nature Reserve is planned for the site Osek. This site together with the other sites should be the part of a bio-corridor of the Territorial System of Ecological Stability with higher than regional importance. It will be important to support a decision process with results of ecological studies. Buying in land around the river that is necessary for the establishment of this bio-corridor is still a very big problem. Another danger is that voices calling for construction of polders or reservoirs as means of flood protection may divert the decision making process from the best way of the river restoration.
